Basic Detail Report

Title Pipe

Date mid 19th century

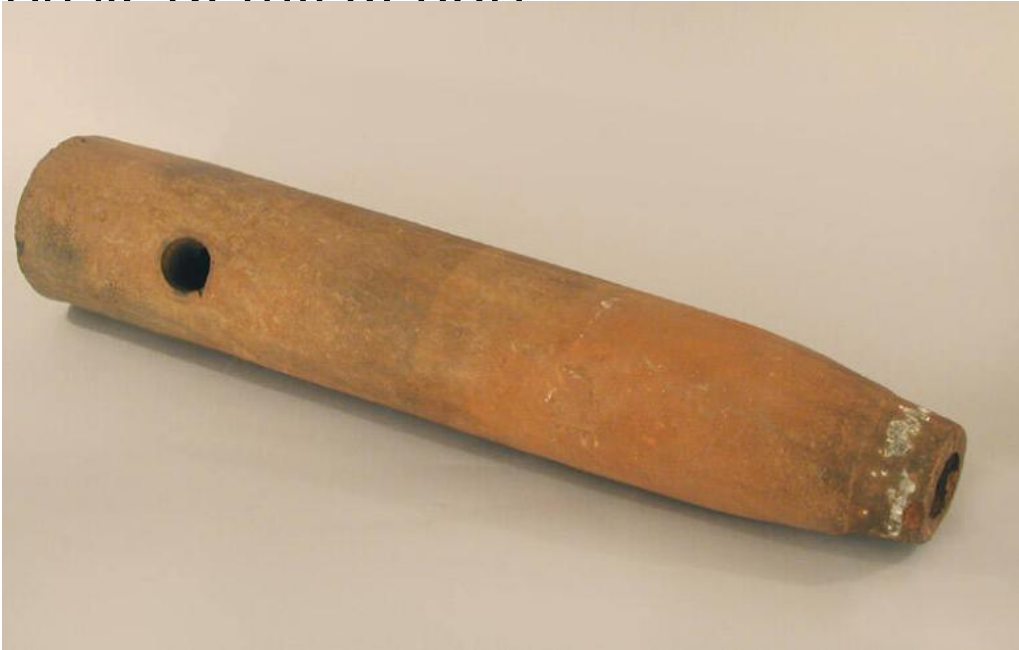
Description Heavy, thick, unglazed, redware pipe with a hollow, cylindrical center and tapered, exterior form. At the widest end of the pipe, the cylindrical, hollow area is widened to accommodate the narrow end of another length of pipe. A cylindrical hole, 1 1/2 inches in diameter, is located about 5 5/8 inches from the widest end of the pipe; the hole pierces one wall of the pipe but does not extend past the hollow cylindrical center running the length of the pipe. The exterior of the pipe is an uneven red and black color; two mold lines extend the length of the pipe. There are two chips in the redware at the widest end of the pipe, and multiple small chips in the redware at the narrower end of the pipe. An unknown white substance has adhered to the exterior of the narrow end, and the interior of the widest end. The exterior of the pipe is pitted and uneven.

Dimensions Primary Dimensions (length x diameter): 23 1/4 x 4 3/8in. (59.1 x 11.1
cm)
