Title Bulkeley Bridge Construction: Abutments and Temporary Iron

Bridge, Hartford

Date 1906

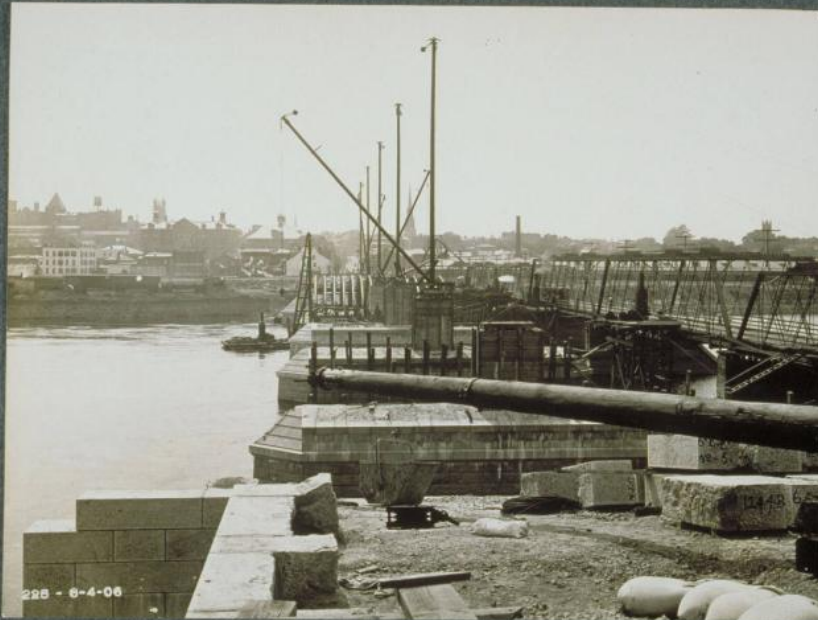
Description View looking west towards the Hartford skyline. The steeples of Christ Church and the Fourth Congregational Church are visible. Freight cars are on railroad tracks of the Connecticut Valley Railroad on the embankment.

Laundry hangs from clotheslines in back of residential buildings. Five stone abutments, complete to the point of the springing of the arches, are in the river.

One arch is partially framed with wooden ribs used for centering the spans.

Cranes loom overhead. A barge appears to have a steam engine on it. Wooden pilings in the river between the abutments form the base for additional arches. A large bucket, a coil of rope, numbered granite blocks, and bags (of cement?) are

on the nearest abutment. The temporary iron bridge is immediately to the right.

Ladders connect the bridge to the construction site.
